NATIONAL PROGRAM FOR INSPECTION OF NON-FEDERAL DAMS
LOWER EDDY POND DAM (...U) CORPS OF ENGINEERS WALTHAM
MA NEW ENGLAND DIV MAR 81

4. TITLE (and Subtitle) Lower Eddy Pond Dam NATIONAL PROGRAM FOR INSPECTION OF NON-FEDERAL DAMS		5. TYPE OF REPORT & PERIOD COVERED INSPECTION REPORT
7. AUTHOR(s) U.S. ARMY CORPS OF ENGINEERS NEW ENGLAND DIVISION		6. PERFORMING ORG. REPORT NUMBER

LOWER EDDY POND DAM

RUTLAND, VT.

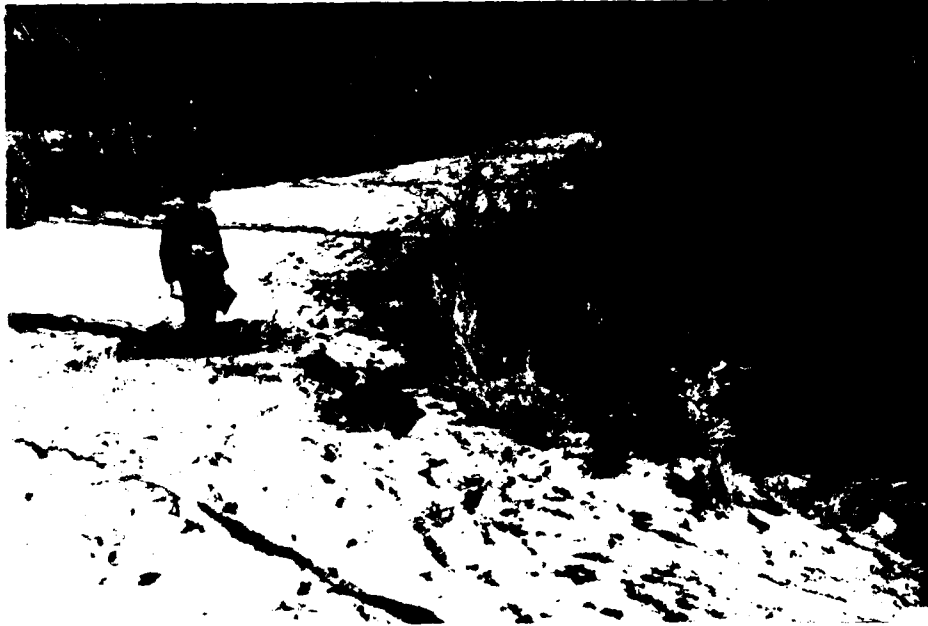
The dam is showing signs of serious internal erosion by piping as evidenced by a 2-foot diameter, 1-foot deep sink hole on the crest located approximately 180 feet west of the center of the spillway (see Photographs 5 and 6, Appendix C). The piping condition is further manifested by a collapsed area at the upstream face of the dam opposite the sinkhole where a flow of water can be seen entering the embankment (see Photograph 8, Appendix C). Water can be observed exiting from collapsed and undermined areas at the downstream slope approximately 140 feet west of the center of the spillway (see Photograph 11, Appendix C). (The exiting flow rate was visually estimated to be between 25 and 50 gallons per minute.) Fine grained soil deposits are visible in areas where the flow emerges from the dam embankment (see Photograph 12, Appendix C).

The sides of the sink hole show bare earth which indicate that this is an active feature. The owners' representative stated that the sink hole had not been noted during summer of 1980.

Photograph 5 - View of 2-foot diameter, 1-foot deep sink hole on crest of dam (Photograph 6) and collapsed area on upstream face (Photograph 8). Excavated area in front of sink hole is man made.
